REPORT TECHNICAL INSPECTION  
WINDPARK HONDTOCHT 06, 783876  
ENERCON E70 E4 – 2300KW - 50HZ

Hondweg, Dronten, The Netherlands

E702022016, Windpark Hondtocht 06 - 783876 - TURBINE\_EN - REV.01

07/06/2022

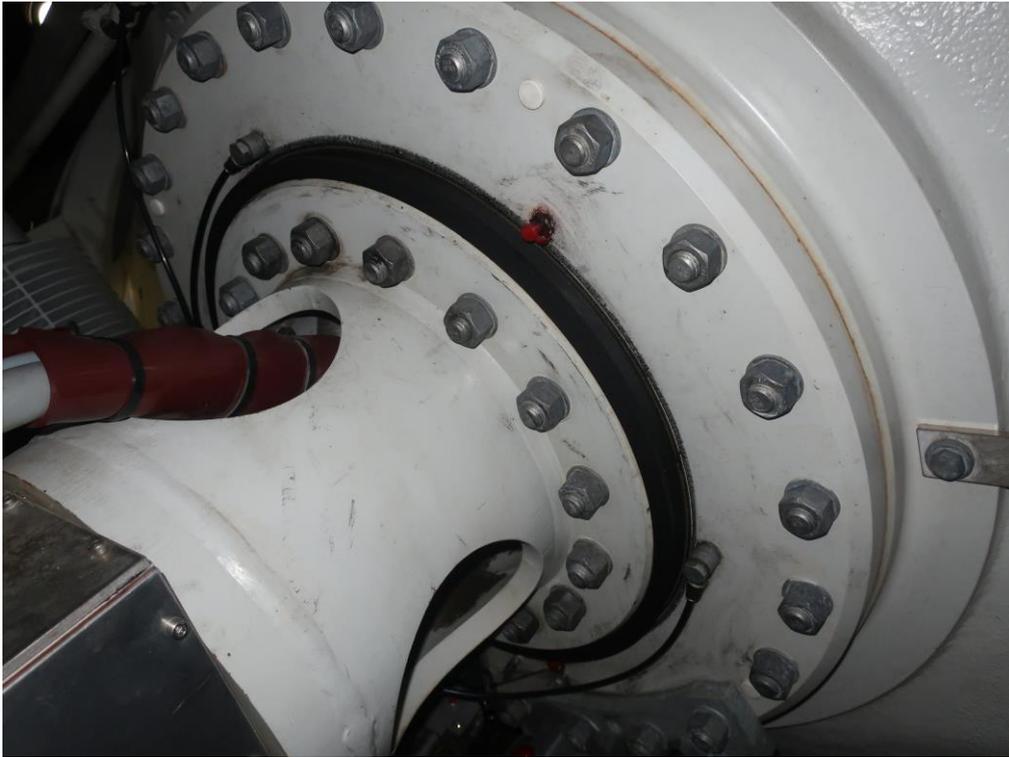
**Front bearing: No irregularities. No grease to check.**

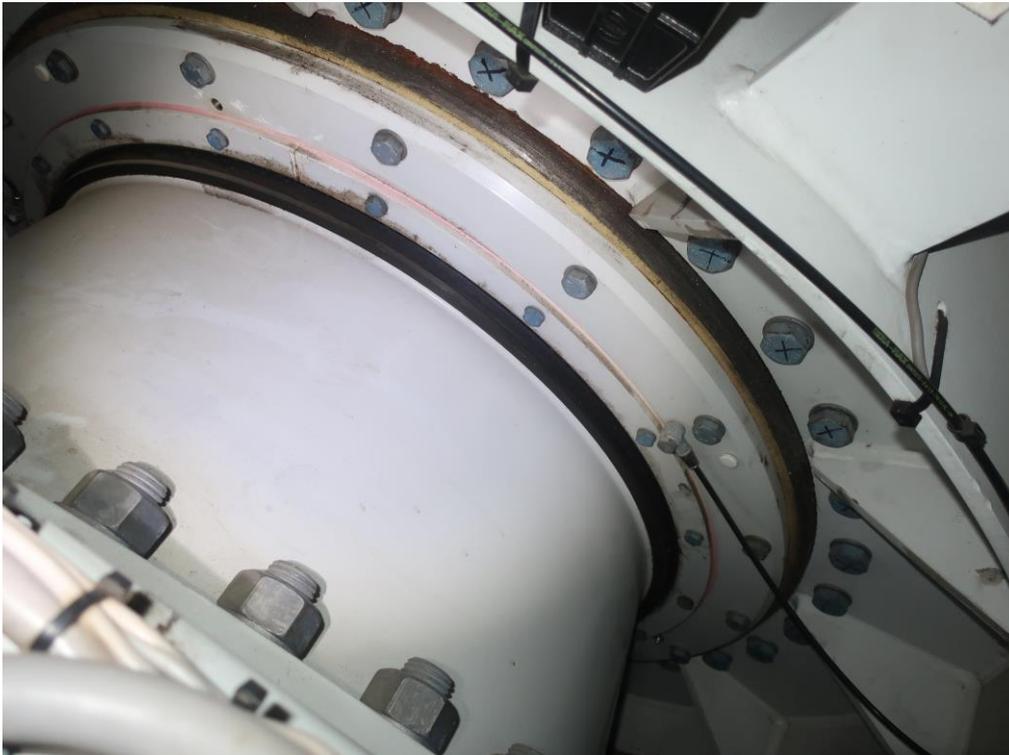
**Rear bearing: No irregularities. No grease to check.**

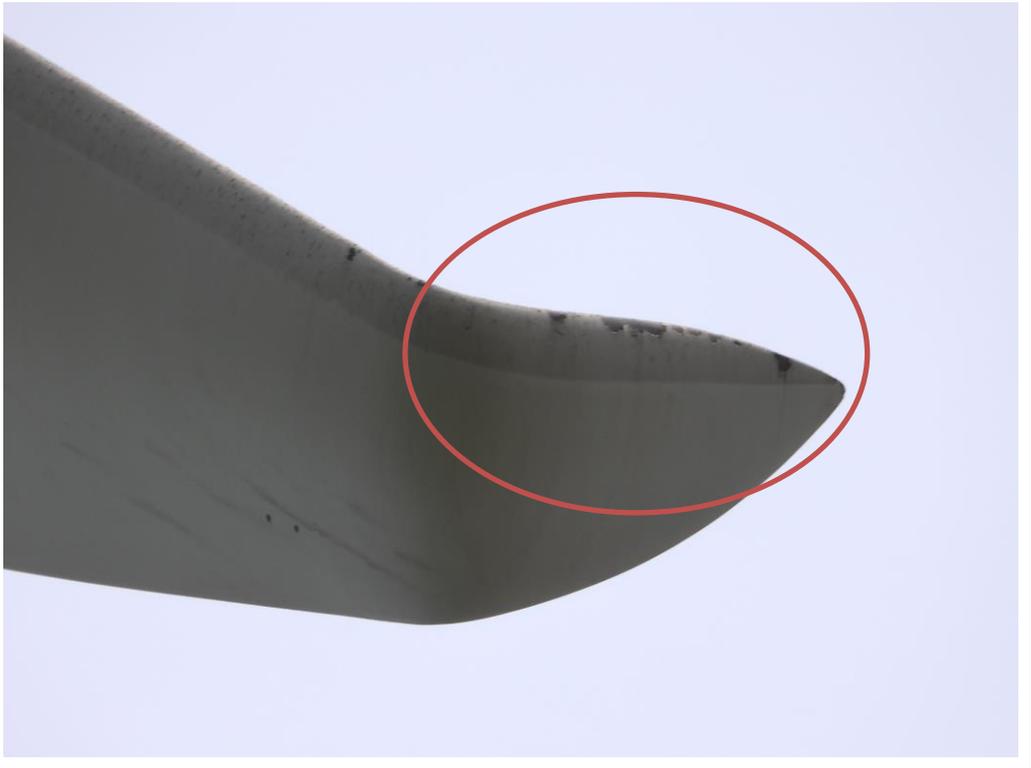
<i>Blades Outside</i>		<i>Blade tips</i>
<b>1.</b>	<b>High</b>

<p>Erosion of the leading edge protection is present at the tip of the blades.</p>

Issue	Description
1 2	<p><u>Erosion of the leading edge protection is present at the tip of the blades.</u></p> <p>The erosion is not extreme, but it is recommended to repair the protective top layer before the underlying composite will get exposed to the elements.</p>
9	<p><u>Several oil drops are present underneath the hoist of the service lift.</u></p> <p>The drops appear to be caused by the hoisting cable which has been oiled/greased quite abundantly.</p> <p>It is recommended to clean the affected areas and to verify that the oil is NOT caused by leakage of the gearbox of the hoist.</p> <p>If leakage of the gearbox of the hoist is present it is likely that the hoist has to be sent to Goracon for revision/repairs.</p>

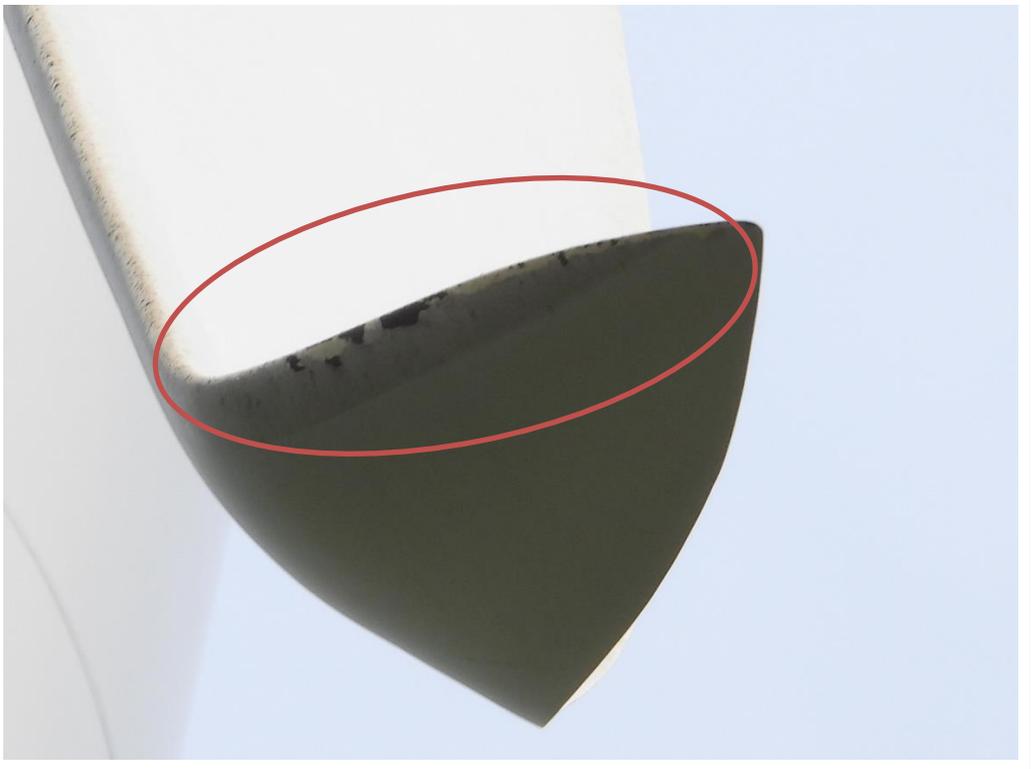
<i>Blades Outside</i>		<i>Blade tips</i>
<b>2.</b>	<b>High</b>

<p>Erosion of the leading edge protection is present at the tip of the blades.</p>

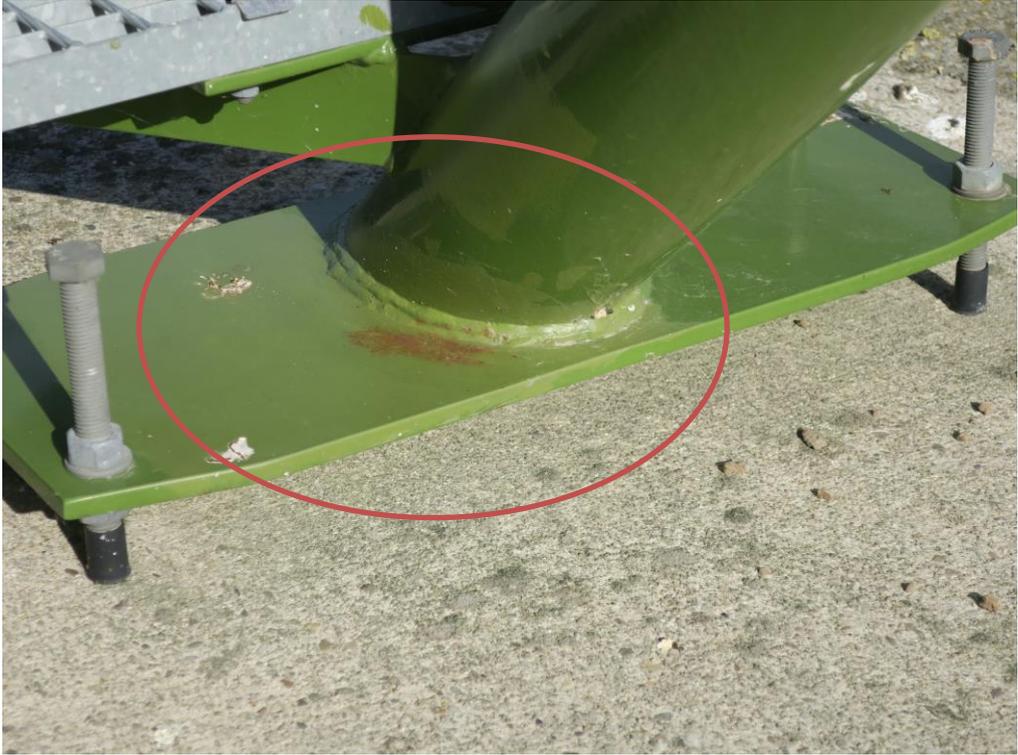
<i>Outside</i>		<i>Surface protection</i>
<b>3.</b>	<b>Low</b>

Minor surface protection damage.

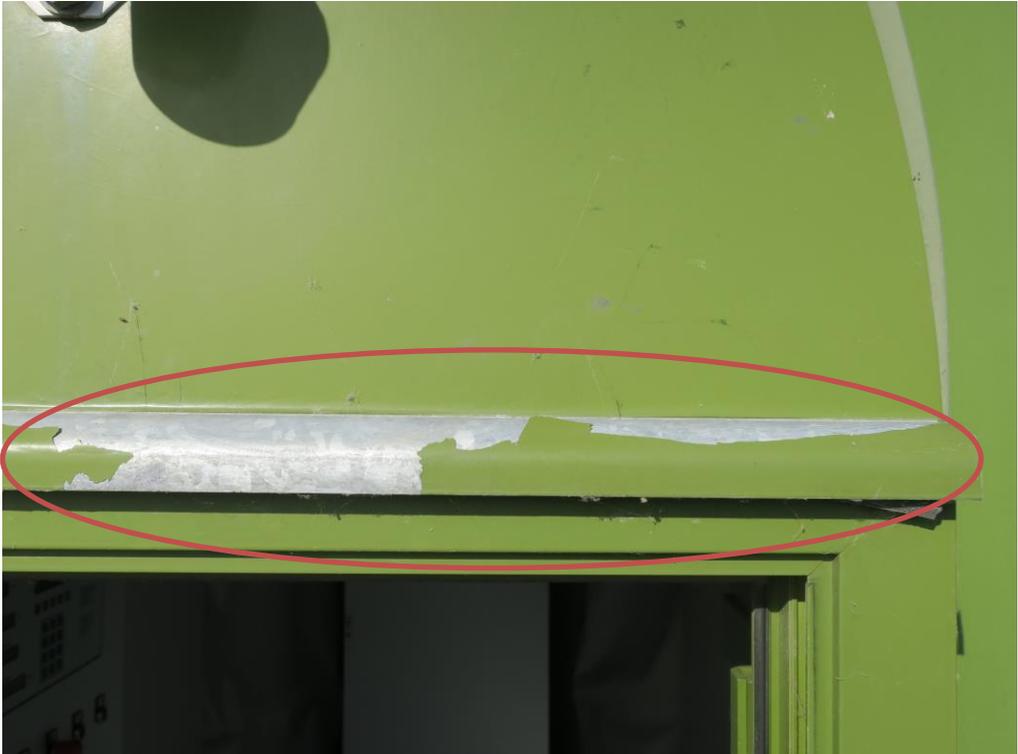
<i>Outside</i>		<i>Surface protection</i>
<b>4.</b>	<b>Low</b>

Minor surface protection damage.

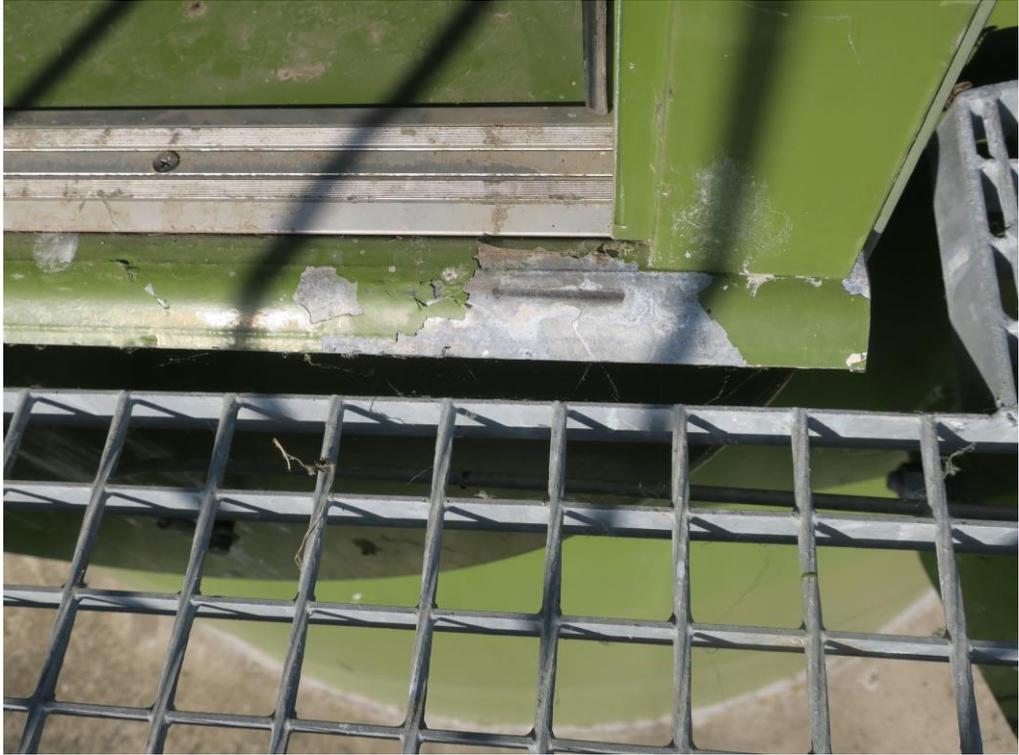
<i>Outside</i>		<i>Surface protection</i>
<b>5.</b>	<b>Low</b>

<p>Minor surface protection damage.</p>

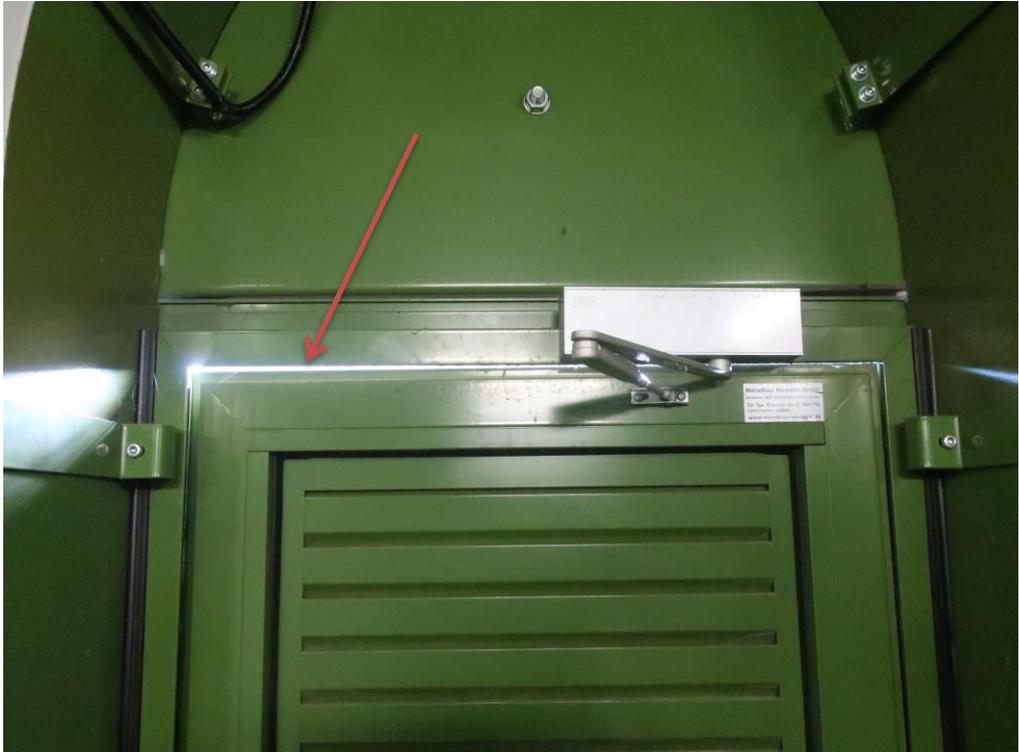
<i>Inside</i>		<i>Door alignment</i>
<b>6.</b>	<b>Low</b>

<p>The door is not properly aligned.</p> <p>As a result, the door is not completely secured against the intrusion of water from outside.</p> <p>The door is also a bit difficult to open because it gets stuck at the bottom.</p>

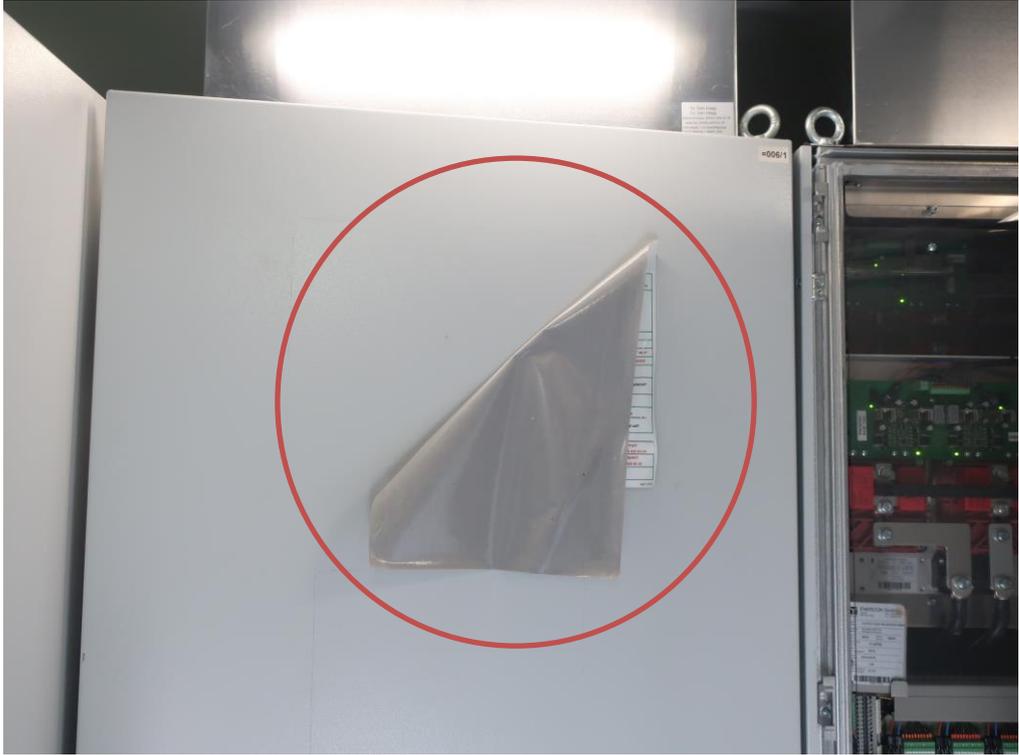
<i>Inside</i>		<i>Emergency charts (1/2)</i>
<b>7.</b>	<b>Low</b>

<p>The emergency charts are not properly attached to the surface.</p>

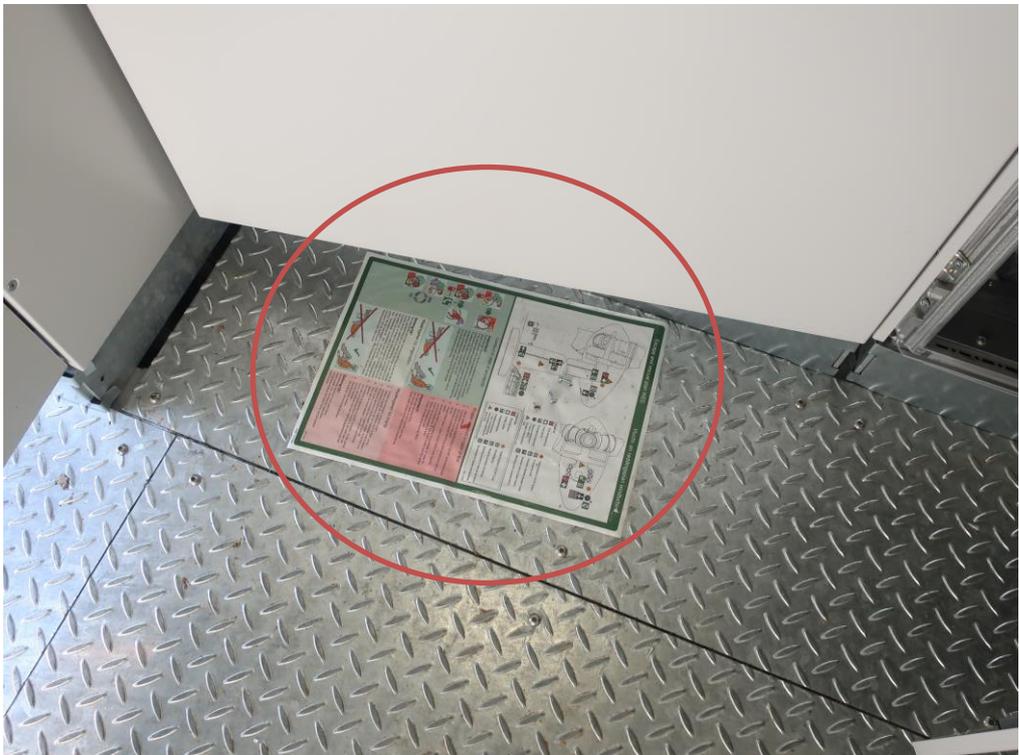
<i>Inside</i>		<i>Emergency charts (2/2)</i>
<b>8.</b>	<b>Low</b>

<p>The emergency charts are not properly attached to the surface.</p>

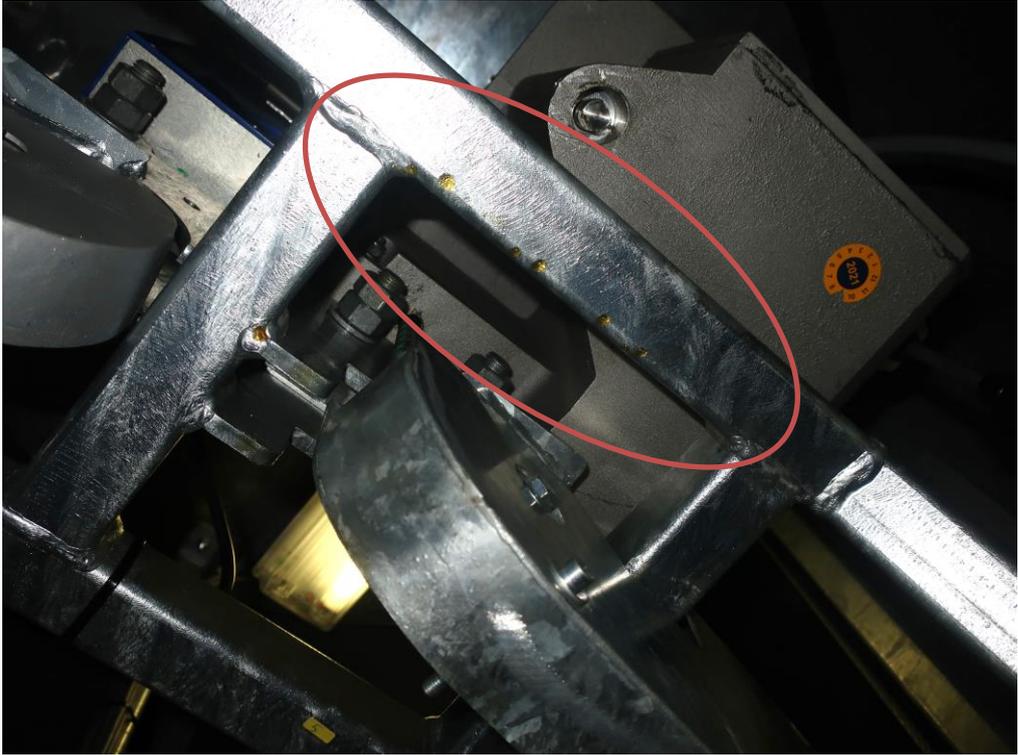
<i>Inside</i>		<i>Service lift: Drops of oil</i>
<b>9.</b>	<b>Safe</b>

<p>Several oil drops are present underneath the hoist of the service lift.</p>

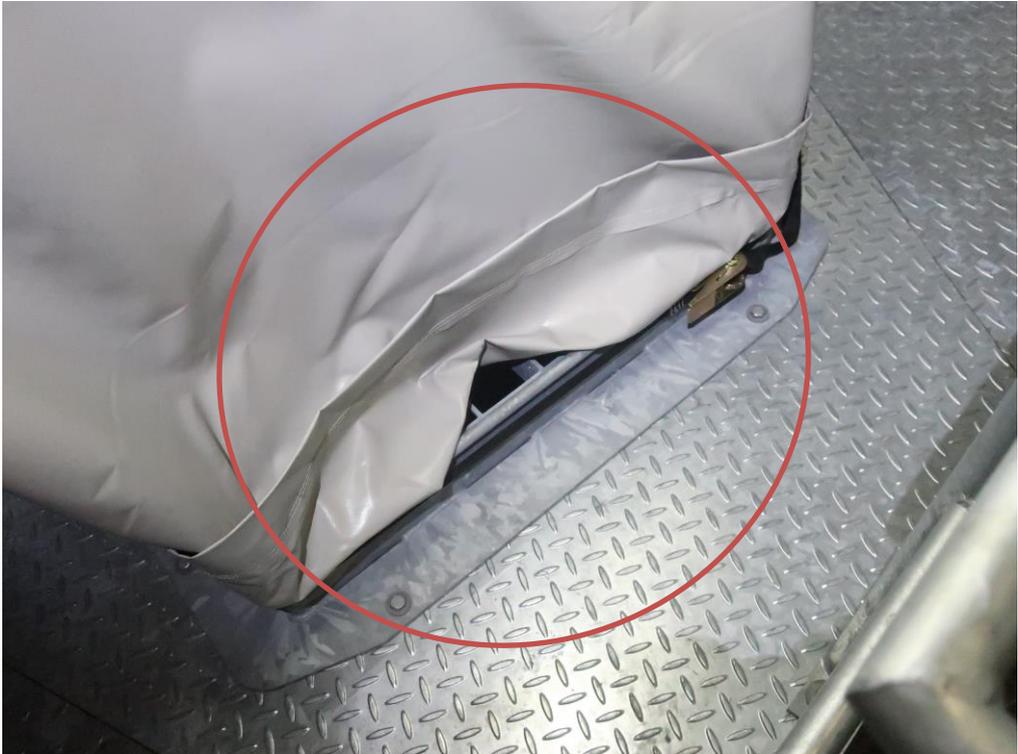
<i>Tower inside</i>		<i>Air duct 1<sup>st</sup> flange</i>
<b>10.</b>	<b>Low</b>

<p>The flexible air duct is not properly installed onto the platform.</p>

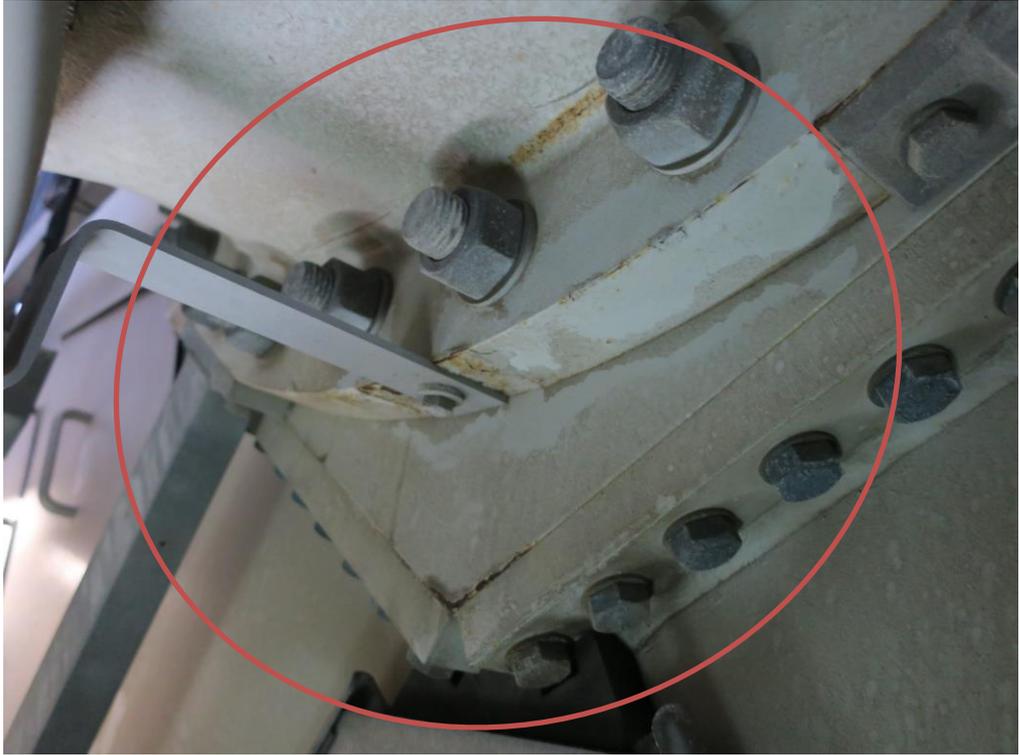
<i>Nacelle</i>		<i>Main shaft housing</i>
<b>11.</b>	<b>Low</b>

<p>Minor corrosion at the bottom of the main shaft housing.</p>

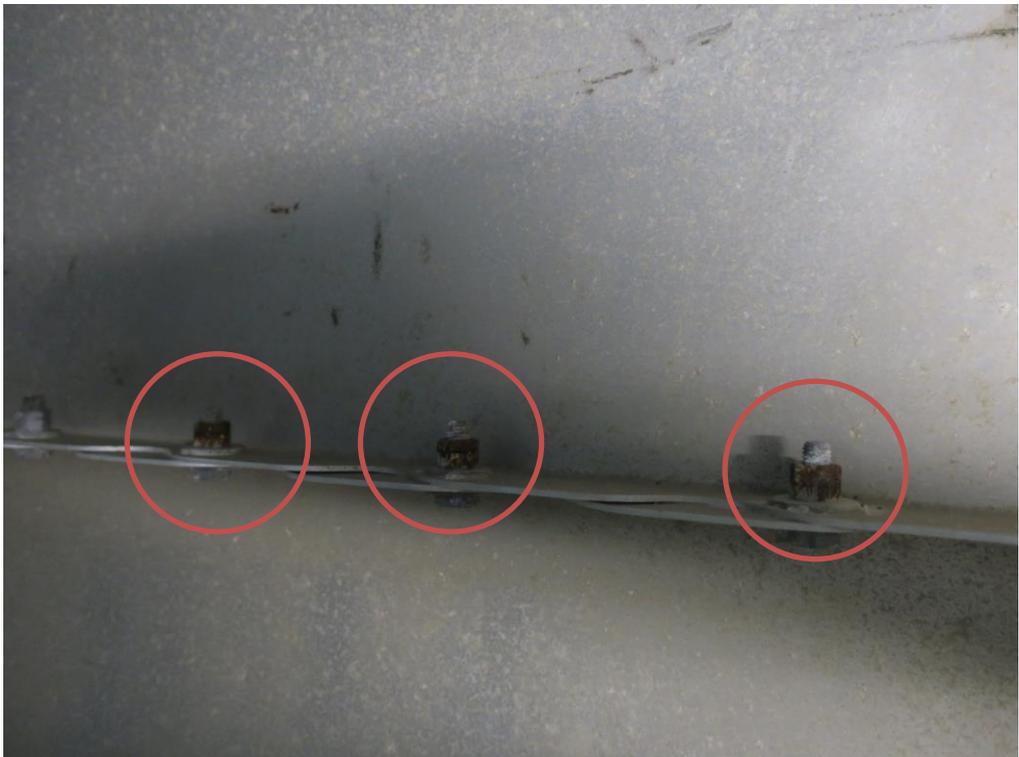
<i>Nacelle</i>		<i>Nacelle bottom corrosion</i>
<b>12.</b>	<b>Low</b>

<p>Almost all the bolt connections of the nacelle covers show corrosion.</p>

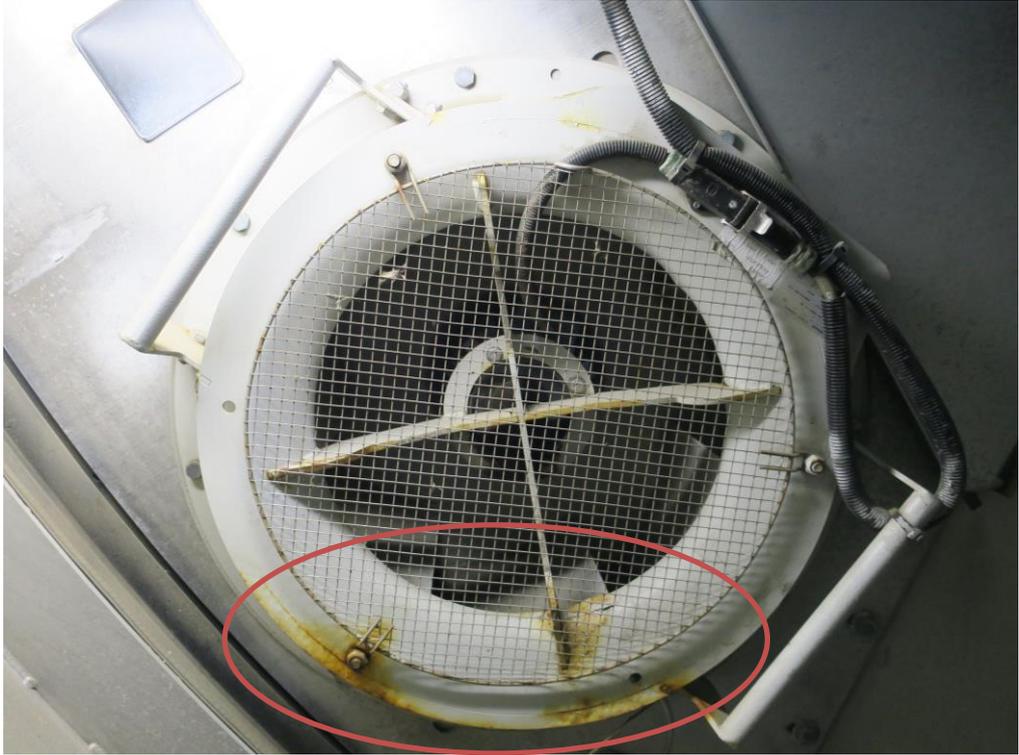
<i>Nacelle</i>		<i>Generator cooling fans</i>
<b>13.</b>	<b>Low</b>

<p>Minor corrosion is present at the cooling fans in the basement of the nacelle.</p>

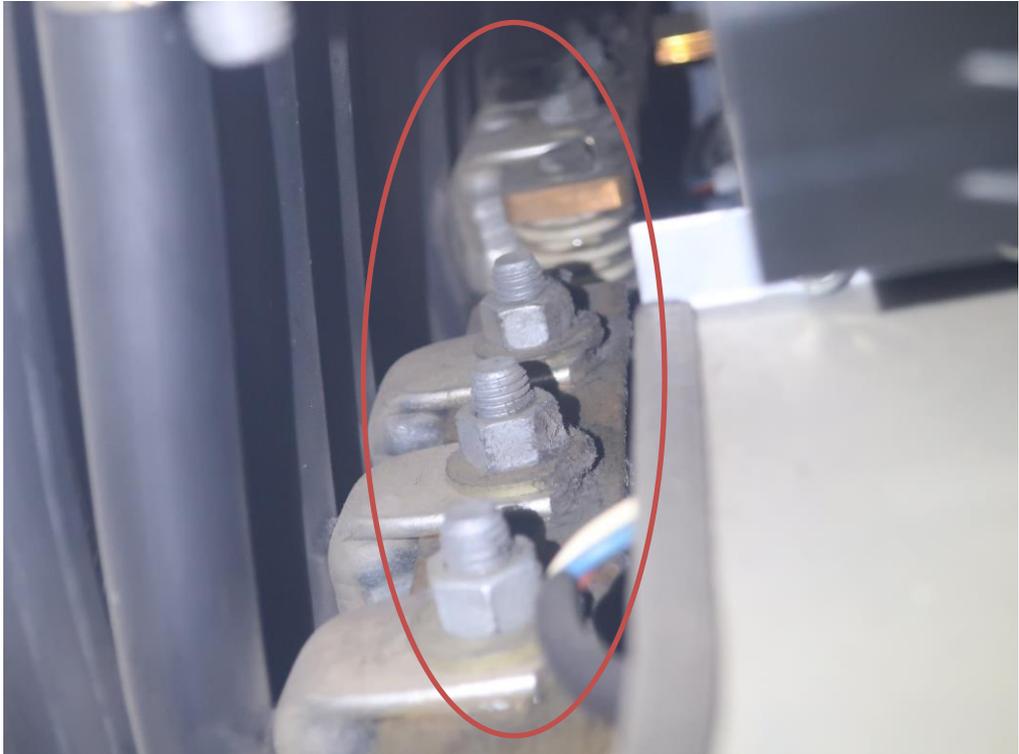
<i>Nacelle</i>		<i>Box 017: Minor pollution dust</i>
<b>14.</b>	<b>Low</b>

<p>Bus bars and connections are covered in dust.</p> <p>It is recommended to clean the affected areas at the next electrical maintenance.</p>

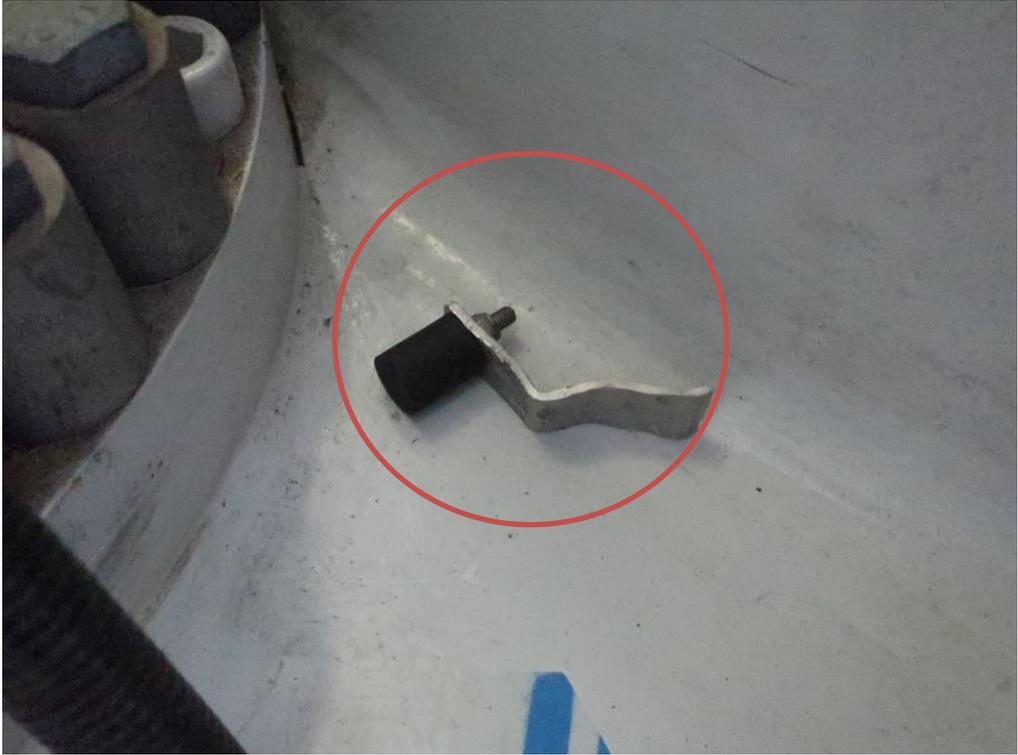
<i>Nacelle</i>		<i>Bracket to secure the roof hatch lock</i>
<b>15.</b>	<b>Low</b>

<p>The bracket to secure the roof hatch lock is not installed and is present on the nacelle floor.</p>

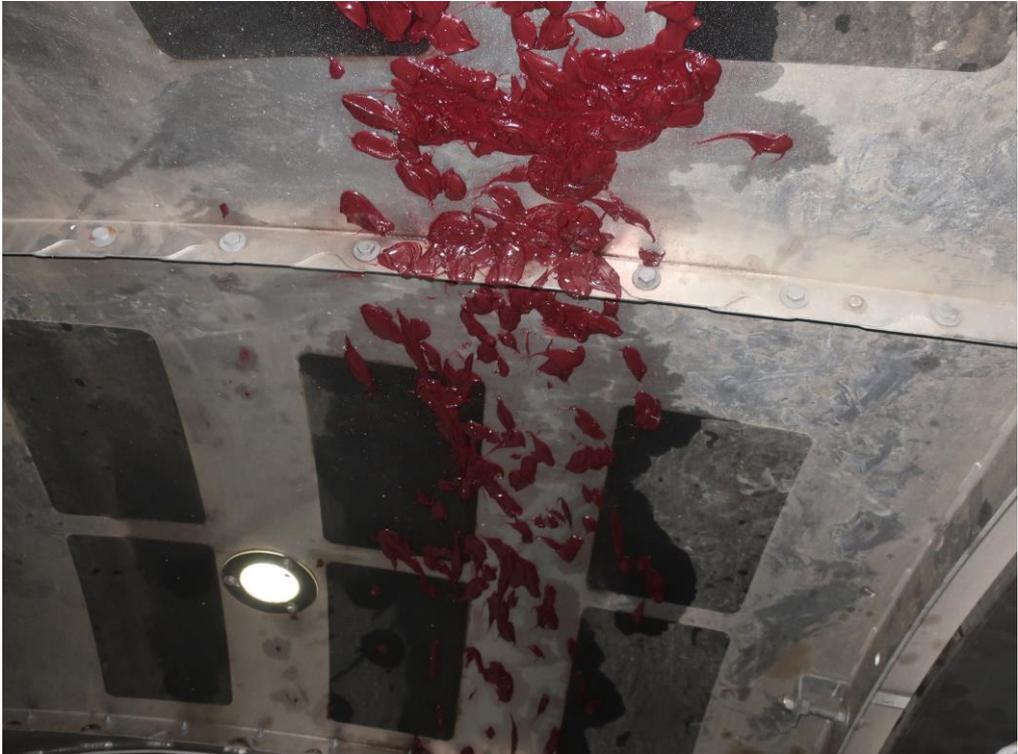
<i>Rotor</i>		<i>Pollution with grease</i>
<b>16.</b>	<b>Low</b>

<p>Minor pollution from the grease from the blade bearings.</p>

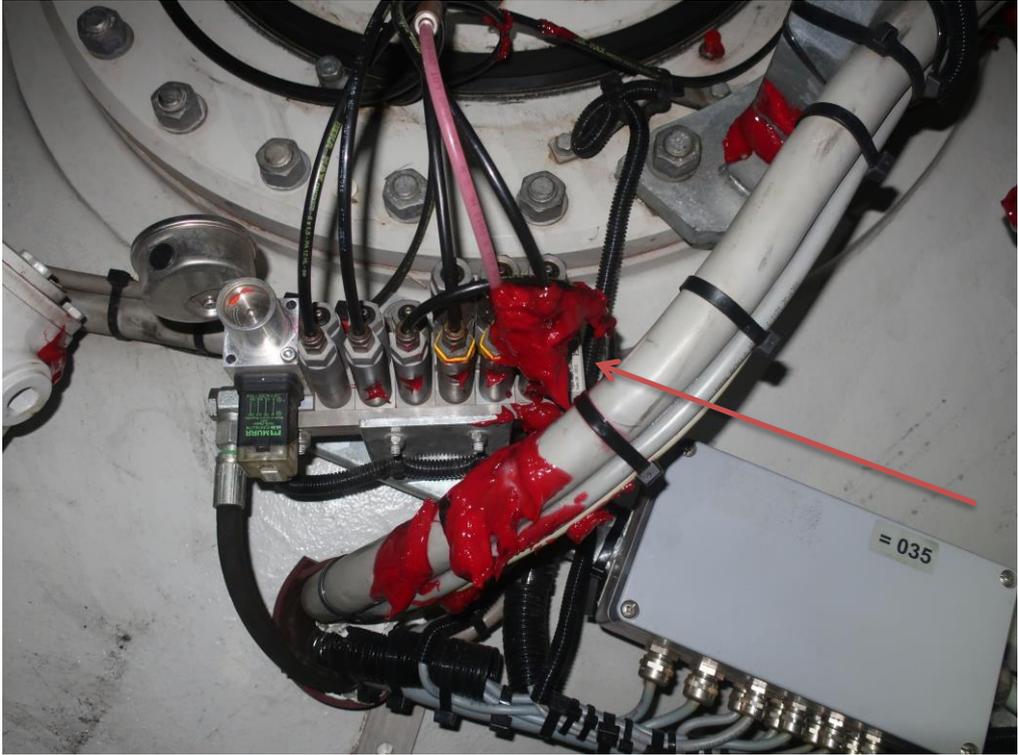
<i>Rotor</i>		<i>Grease distribution block</i>
<b>17.</b>	<b>Low</b>

<p>Leakage is present at the grease distribution block at the front of the rotor.</p>

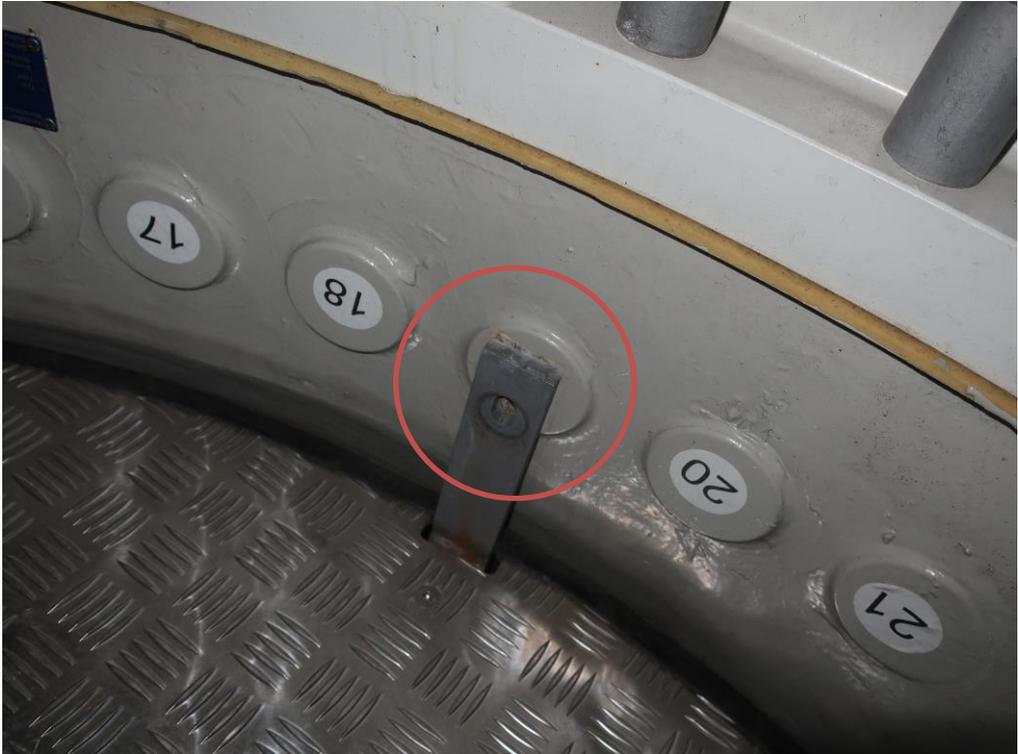
<i>Rotor</i>		<i>Blade platform 2482</i>
<b>18.</b>	<b>Safe</b>

<p>The bolt connection of the blade platform is missing.</p> <p>It is highly recommended to repair the bolt connection.</p>
